BUILDING INSPECTION REPORT

BOO-28429-N8B1F7
Report Number

2 Eungai Place, North Narrabeen, NSW 2101
Inspection Address

23/01/2019
Date of Inspection

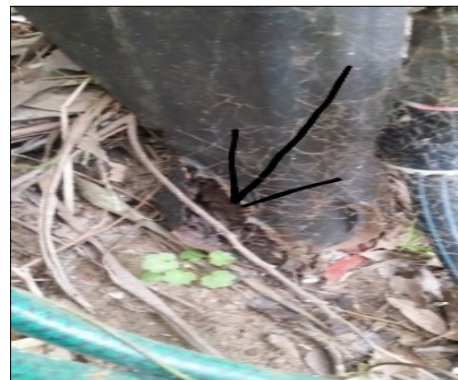
Removal of rust scale and checking of wall thickness of south east corner post to ensure the steel is structurally sound is required. Recommend seeking further advice from a licensed and practicing builder.

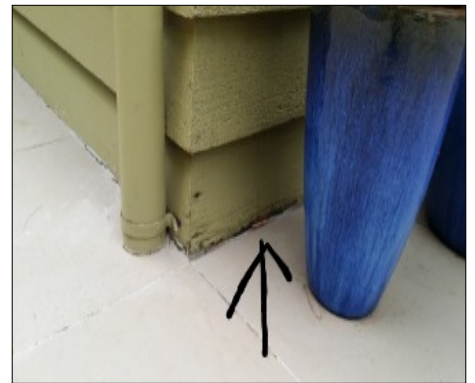
Decay to bottom weatherboards at front corners of dwelling. Rectification recommended.

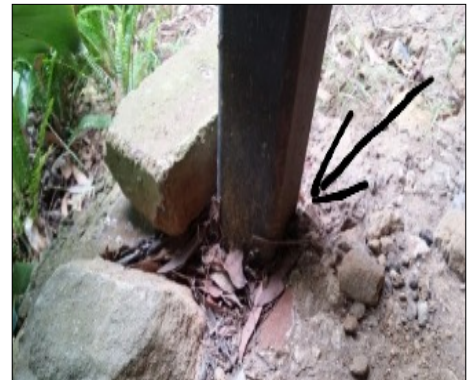
Strongly recommend to clear and divert soils/moisture away from the base of steel posts to prevent rusting/corrosion.

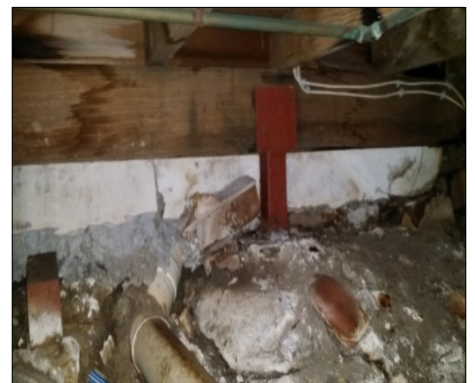
Rust scale detected to the bottom of steel posts at ground level. Rust treatment is required to prevent further corrosion affecting the structural integrity of the post.

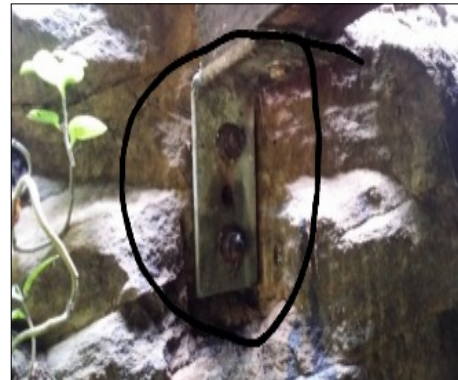
Regular monitoring and maintenance to metal brackets and bolts supporting deck bearers is recommended.

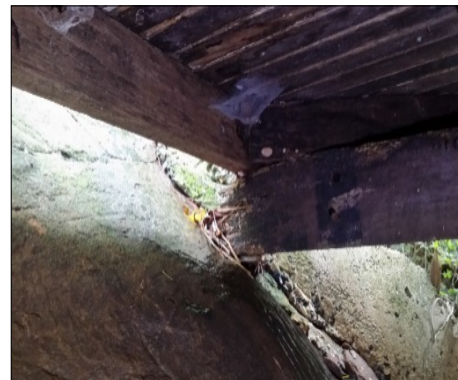
Weathering and small sections of decay to some timber members below entry area deck. Maintenance recommended.

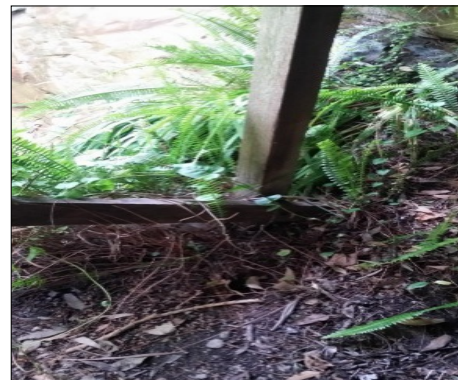
Timber posts to entry area deck should be at least 75mm above finished ground levels to prevent wood decay and possible termite entry. Clearing of vegetation and debris from base of posts is recommended.

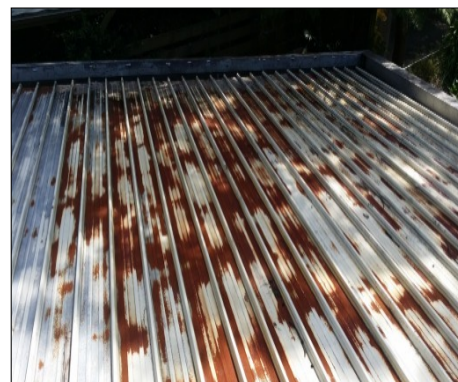
Surface rust to areas of the roof body, these sections should be repaired or replaced. Recommend seeking advice from a licensed and practicing metal roofing contractor.
