TIMBER PEST INSPECTION REPORT

BOO-28429-N8B1F7
Report Number

2 Eungai Place, North Narrabeen, NSW 2101
Inspection Address

23/01/2019
Date of Inspection

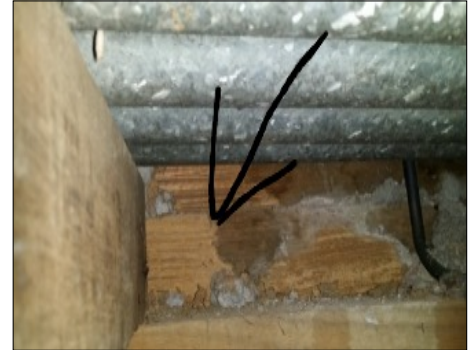
Termite damage or workings were located in the following: **Sub Floor**

The extent of any visible termite workings or damage appears: **Localised**

Termite mudding and damage was detected below the bathroom in the sub floor area.

RECOMMENDATION; Where evidence of damage to building timbers exists or is undetermined, competent advice (e.g. from a licensed and practicing building contractor) should be obtained to determine the extent of any structural damage and as to the need or otherwise for rectification or repair work. See also Item 3.5 'Frequency of Future Inspections' recommendation

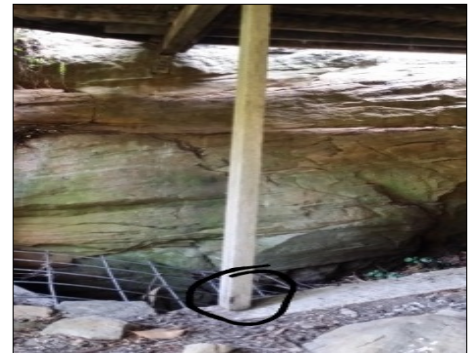
Two entry area balcony supports are in direct ground contact which is always a termite risk and promotes wood rot. Recommend a 75mm clearance from the ground. Recommend seeking further advice from a licensed and practicing carpenter.
