VISUAL VENDOR MAINTENANCE BUILDING INSPECTION REPORT **28507-2017**

Date Inspection carried out: Wednesday, 05th JULY 2017

**3 Sunlea Place,
ALLAMBIE HEIGHTS NSW 2100
0425 257 337**

3 Sunlea Place, ALLAMBIE HEIGHTS.

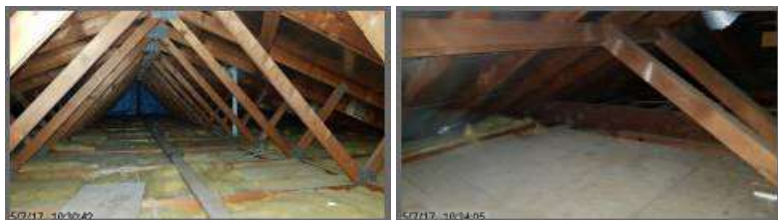
Roof Supports - Type and Condition:

The truss roof system appears adequate for the roof covering.

The cut and pitched roof timbers appear to provide adequate support. It is not uncommon to see minor deflection to the main framing timbers as a result of initial settlement and shrinkage of some framing timbers.

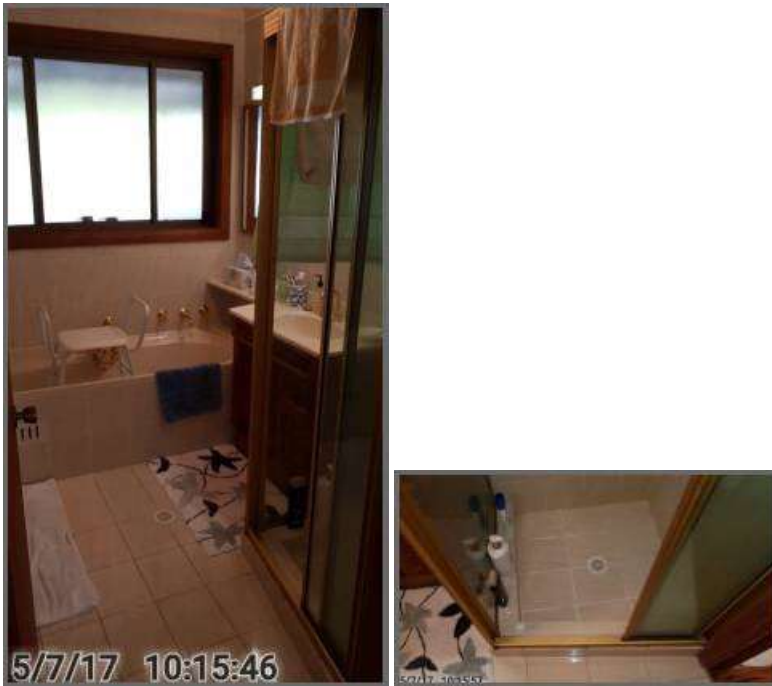
Bathroom facility appears to have been upgraded since original.

The most common cause of leaking showers is due to building movement and settlement causing weakening or cracking of grout, or the waterproof membrane under the tiles fails. At the time of the inspection the shower enclosures were tiled. Accordingly it is impossible to establish if an Australian Standards approved seamless waterproofing membrane system has been installed. Neither shower flooding or water testing or the use of moisture meters can necessarily detect defective showers. It is possible that the vendor may have applied a liquid re-waterproofing system which given time or increased usage may fail. It is also possible that the shower is not in use and that previous signs or leakage have been obscured. Accordingly it is suggested that you discuss the condition of the showers with the vendor and satisfy yourself that the showers do not leak.

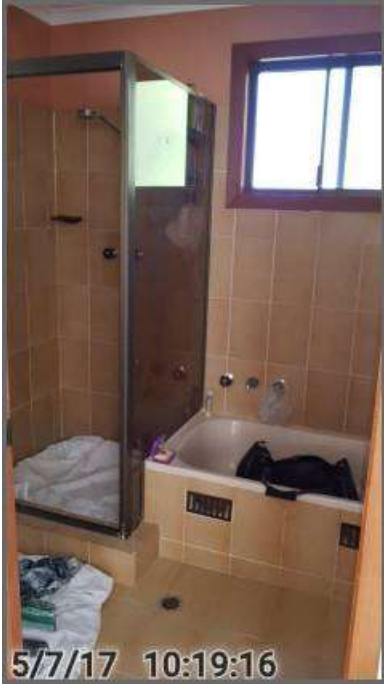
Bathroom / ensuite facility was added at time of extension.

The most common cause of leaking showers is due to building movement and settlement causing weakening or cracking of grout, or the waterproof membrane under the tiles fails. At the time of the inspection the shower enclosures were tiled. Accordingly it is impossible to establish if an Australian Standards approved seamless waterproofing membrane system has been installed. Neither shower flooding or water testing or the use of moisture meters can necessarily detect defective showers. It is possible that the vendor may have applied a liquid re-waterproofing system which given time or increased usage may fail. It is also possible that the shower is not in use and that previous signs or leakage have been obscured. Accordingly it is suggested that you discuss the condition of the showers with the vendor and satisfy yourself that the showers do not leak.

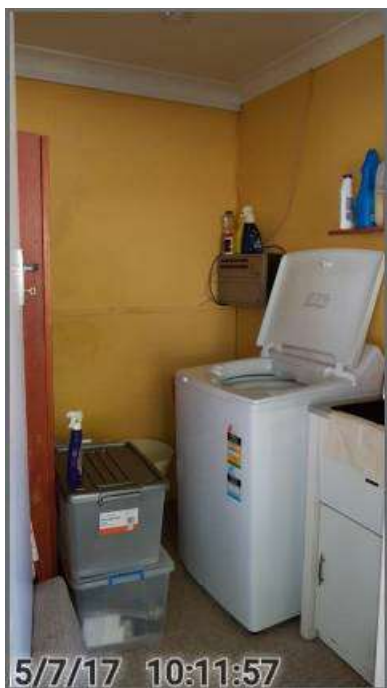
Laundry facility appears to be mainly original, therefore it is considered normal for age and water / exposure degradation to be evident to surrounding areas. This area is generally in acceptable condition. Installation of mechanical ventilation, vented to the outside of the building is recommended.

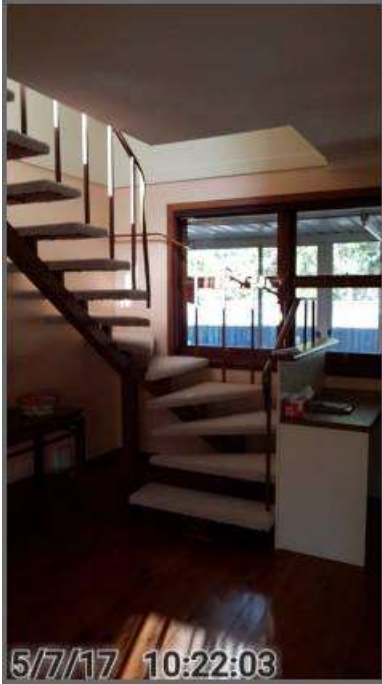
In the interests of safety, shatterproof film or safety glass should be installed to large glass panels within the stair-well and adjacent areas. A licensed glazier should be called to make a further evaluation and repairs or rectification as needed.

The handrails and balustrades may not comply with BCA Standards for height and spacing. We recommend a qualified builder with expertise in timber replacement be engaged to provide a scope of work and associated costs for repairs / upgrading.

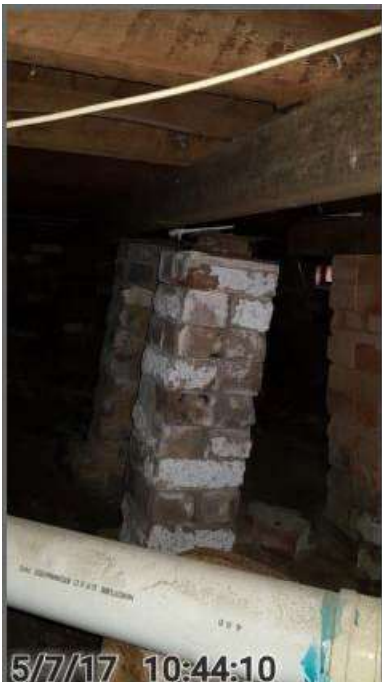
Some degraded ant capping is considered inadequate. This situation can allow concealed termite entry and we recommend that modifications be made. A licensed carpenter should be called to make a further evaluation and repairs or rectification as needed. We strongly recommend that a licensed pest inspector be engaged to inspect the dwelling and replacement should be considered.

Some isolated brick piers have settled. Early wedge-packing of the floor framing timbers above will be required. A licensed builder should be called to make a further evaluation and repairs or rectification as needed.

A licensed builder should be called to make a further evaluation and repairs or rectification as needed.

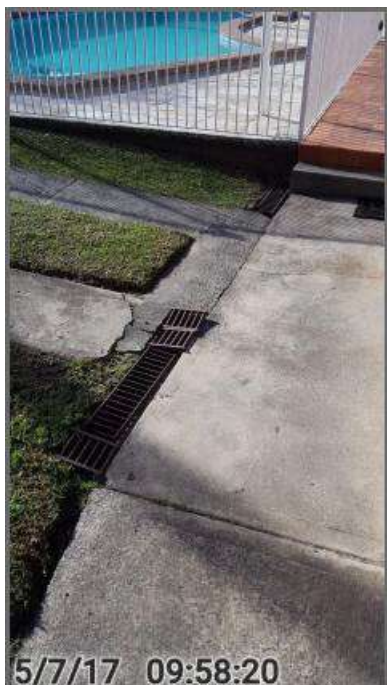
Medium capacity surface water run-off drainage provisions at the base of driveway will require periodical clearing and flushing.

Adequacy or correct function of drainage provisions were not checked at time of inspection. A further inspection is recommended by a licensed plumbing or drainage contractor.

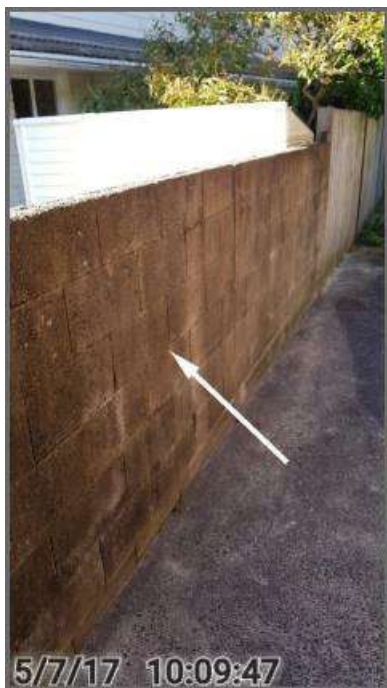
The fences are constructed from timber, brick and concrete blocks.

High masonry fences can be a potential danger from collapse / failure. Where brick fencing is constructed on or around the property, regular checking for defects / movement is recommended.

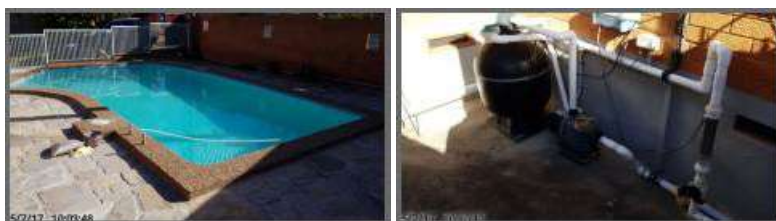
A swimming pool is present. This inspection specifically excludes any inspection of the pool, associated items, child safety fencing or surrounds. It is important that a swimming pool complies with the current Australian Standards. Private pools in NSW rules and regulations vary depending on when the pool was built. For safety purposes it is advised that you keep the pool area as safe as possible by obtaining a qualified professional to inspect the pool.

Construction of suitable pool filtration equipment housing / shelter is recommended to reduce risk of premature degradation to pumping equipment. Exposed electrical components also pose a serious safety hazard. We recommended this area be inspected by a licensed electrical contractor.

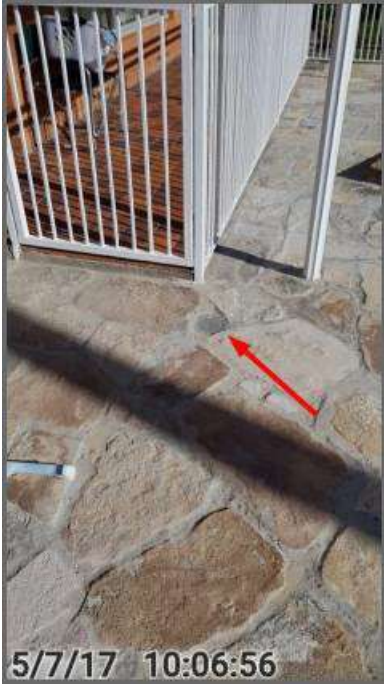
Surface water run-off drainage provisions around the pool areas appears to be acceptable. However, these should be monitored during heavy rain to determine whether the existing drains can cope. If they cannot cope, then additional drains may be required. Early and then periodical clearing and flushing of these existing provisions will be required.

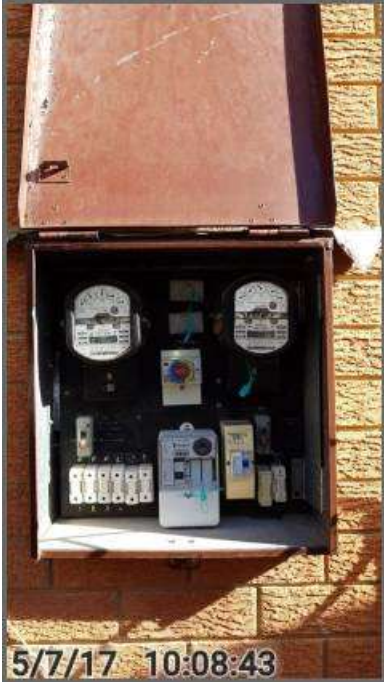
Smoke alarms are fitted, however, the positioning, operation or adequacy was not tested and is not commented on. These devices need to be regularly tested and the batteries changed in accordance with the manufacturers instructions.

Main electrical supply meters and fittings appear to have been modestly upgraded since original, however allowance could be made for further general upgrading and installation of approved "Safety" devices (R.C.D Residual Current Device) and "Hard-Wired" "Smoke-detectors" in the short term to satisfy current building codes. A further detailed investigation (by a competent person e.g. a licensed electrical contractor) is recommended to determine the rectification or repair work costs.
