## VISUAL VENDOR MAINTENANCE PEST INSPECTION REPORT **28507-2017**

**3 Sunlea Place, ALLAMBIE HEIGHTS.**

# VISUAL TIMBER PEST INSPECTION REPORT

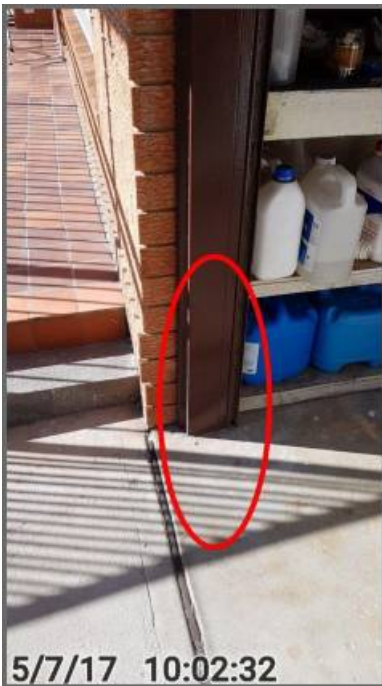
#### **Affected garaging timbers**

The following timbers are in contact with concrete / soil. Direct timber to concrete / soil contact can allow concealed termite entry and we recommend timbers be trimmed at least 75mm above finished floor level. Recommend consult licensed builder to advise further.

Door frame timbers:
